Evaluation of Trial Bunker Hill Mine Water Diversion

DATE: December 20, 2002

On December 19, 2002 Jim Stefanoff and Bill Hudson observed a trial mine water diversion in the Bunker Hill Mine. The purpose of the trial was to test a proposed diversion approach using a temporary dam across the Kellogg Tunnel to back water into the Barney Vent Raise and down to 10 Level. The trial was conducted by employees of The New Bunker Hill Mining Company (NBHMC).

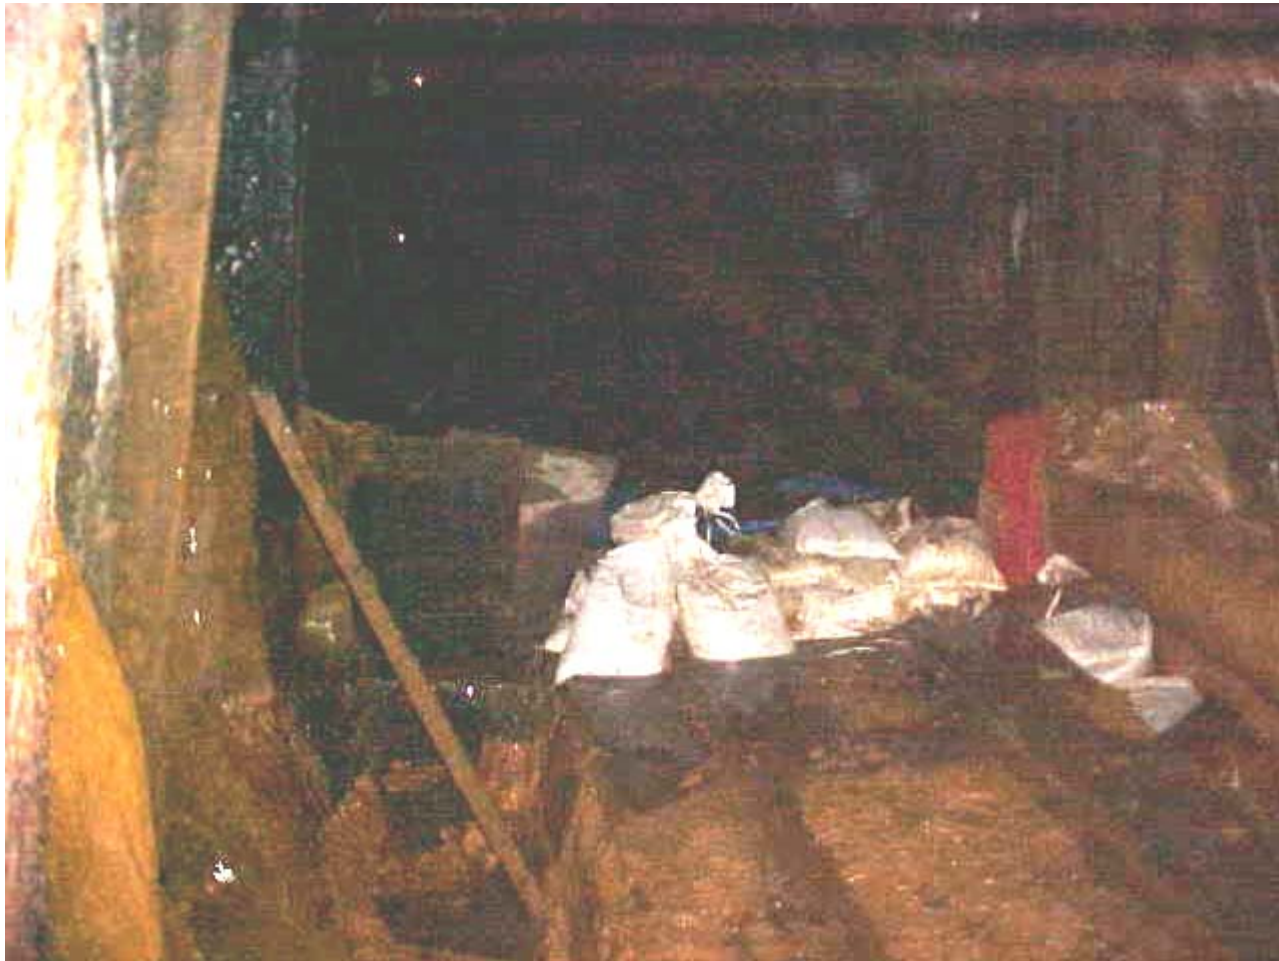
Looking upstream at the face of the trial diversion dam.

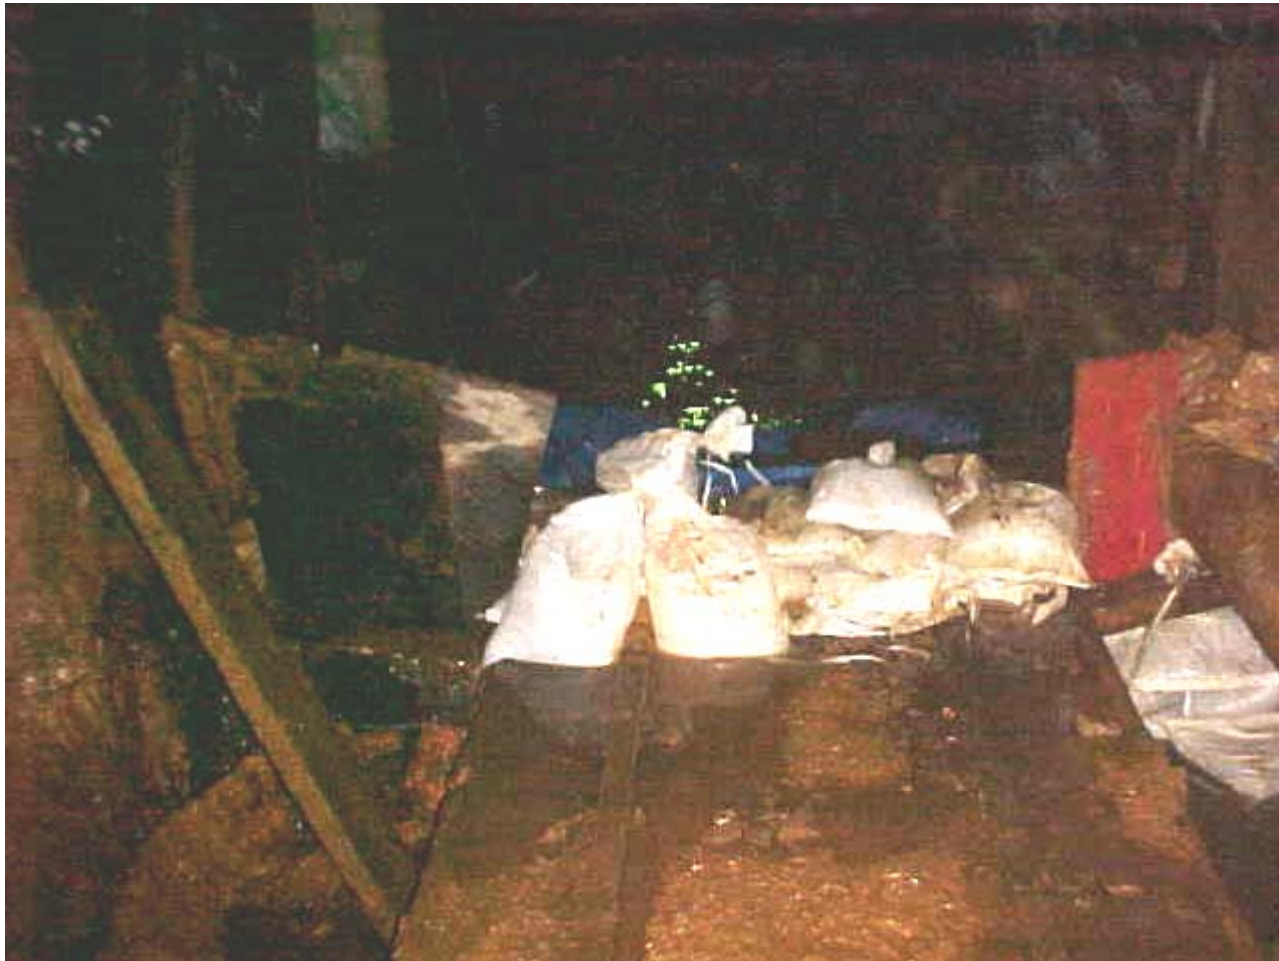
Looking upstream at the face of the trial diversion dam.

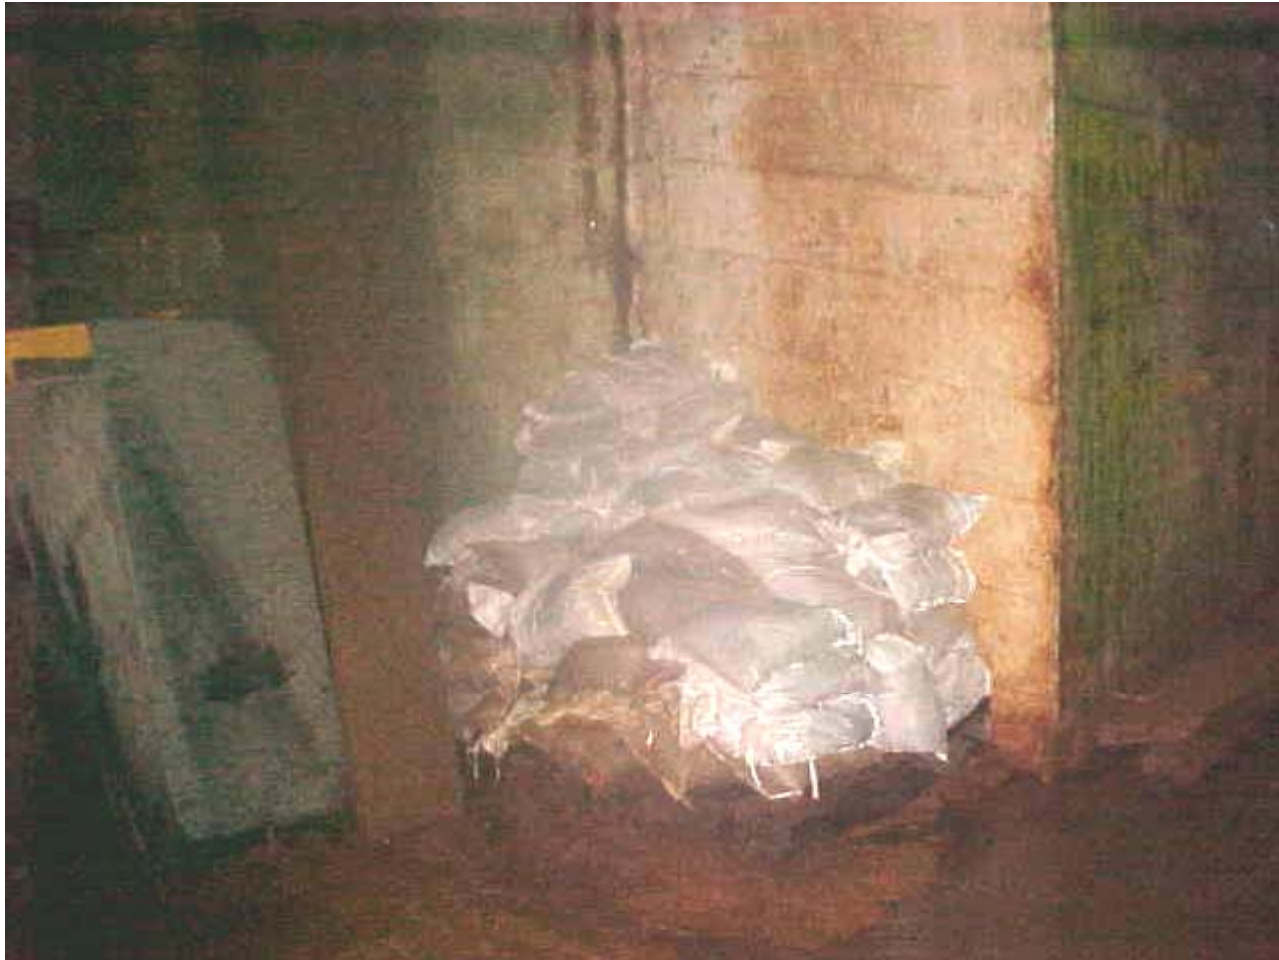
Stockpiled dam building materials located to the side of the dam site.
Materials consist of sand bags, boards, and plastic tarps.

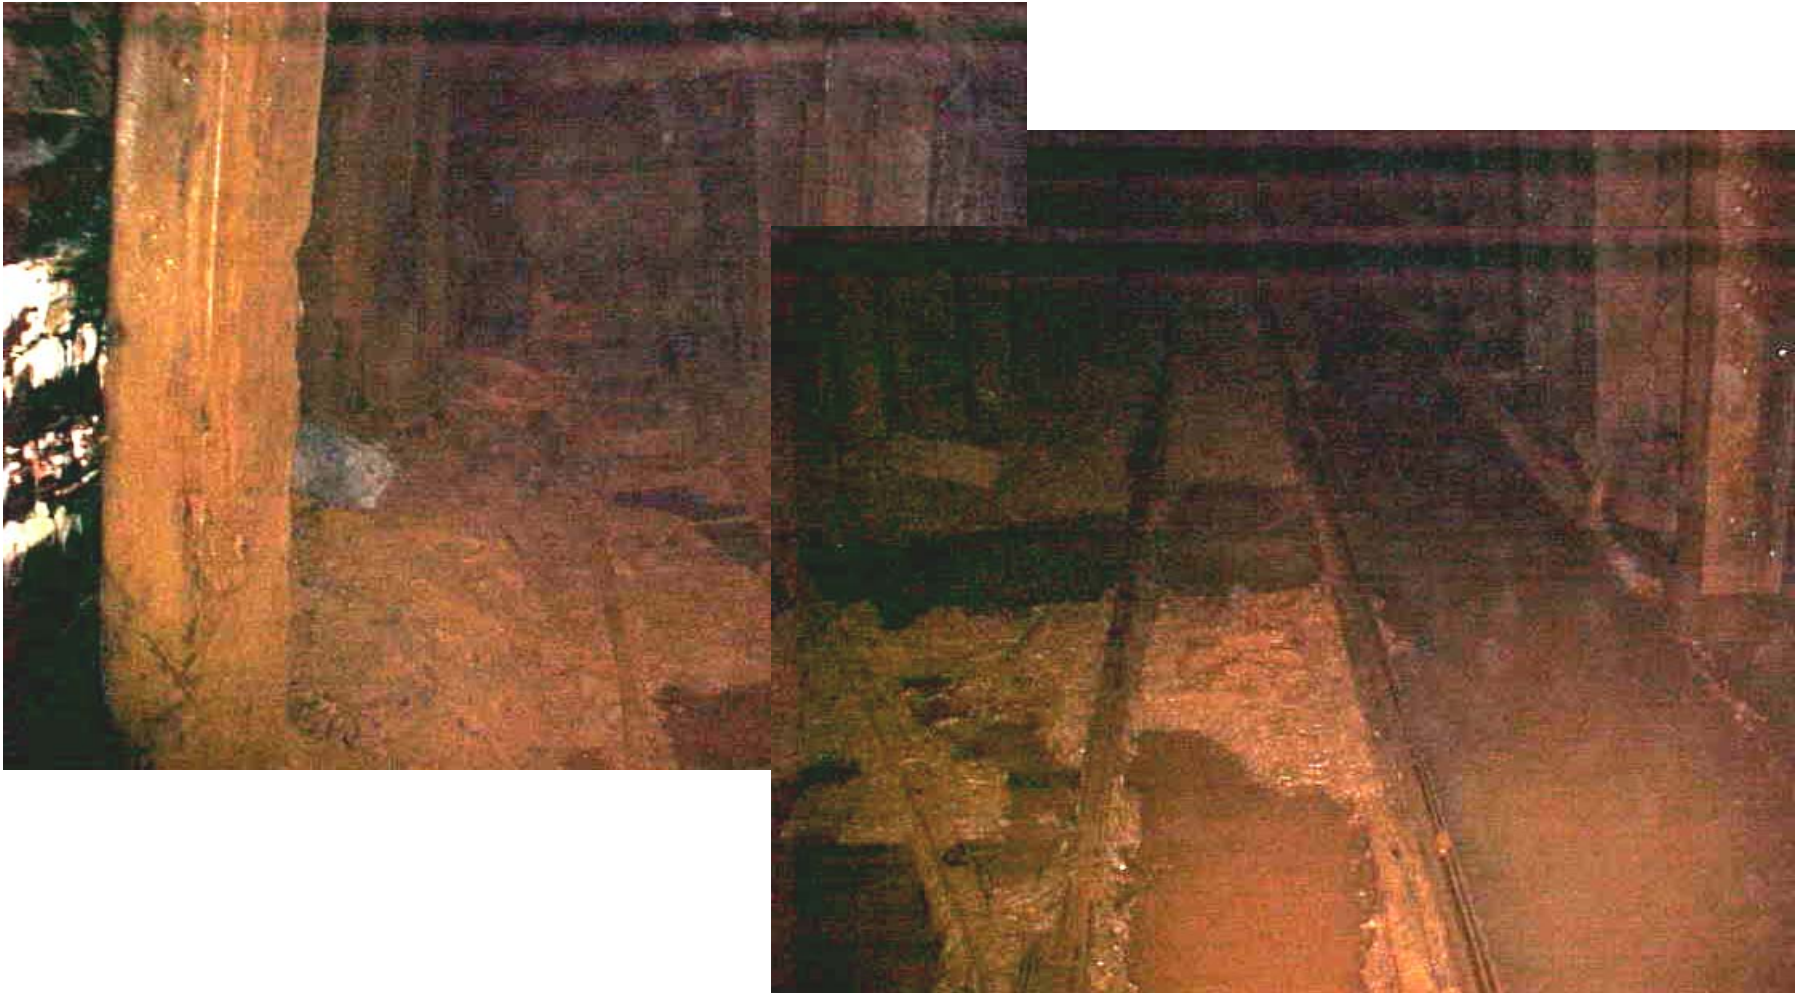
Dammed water backing up the Barney Drift (right side photo) and draining down the Barney Vent Raise (left side photo). The top of the raise is located below the old ore car. The trial diversion dam is about 100 feet behind these photos.

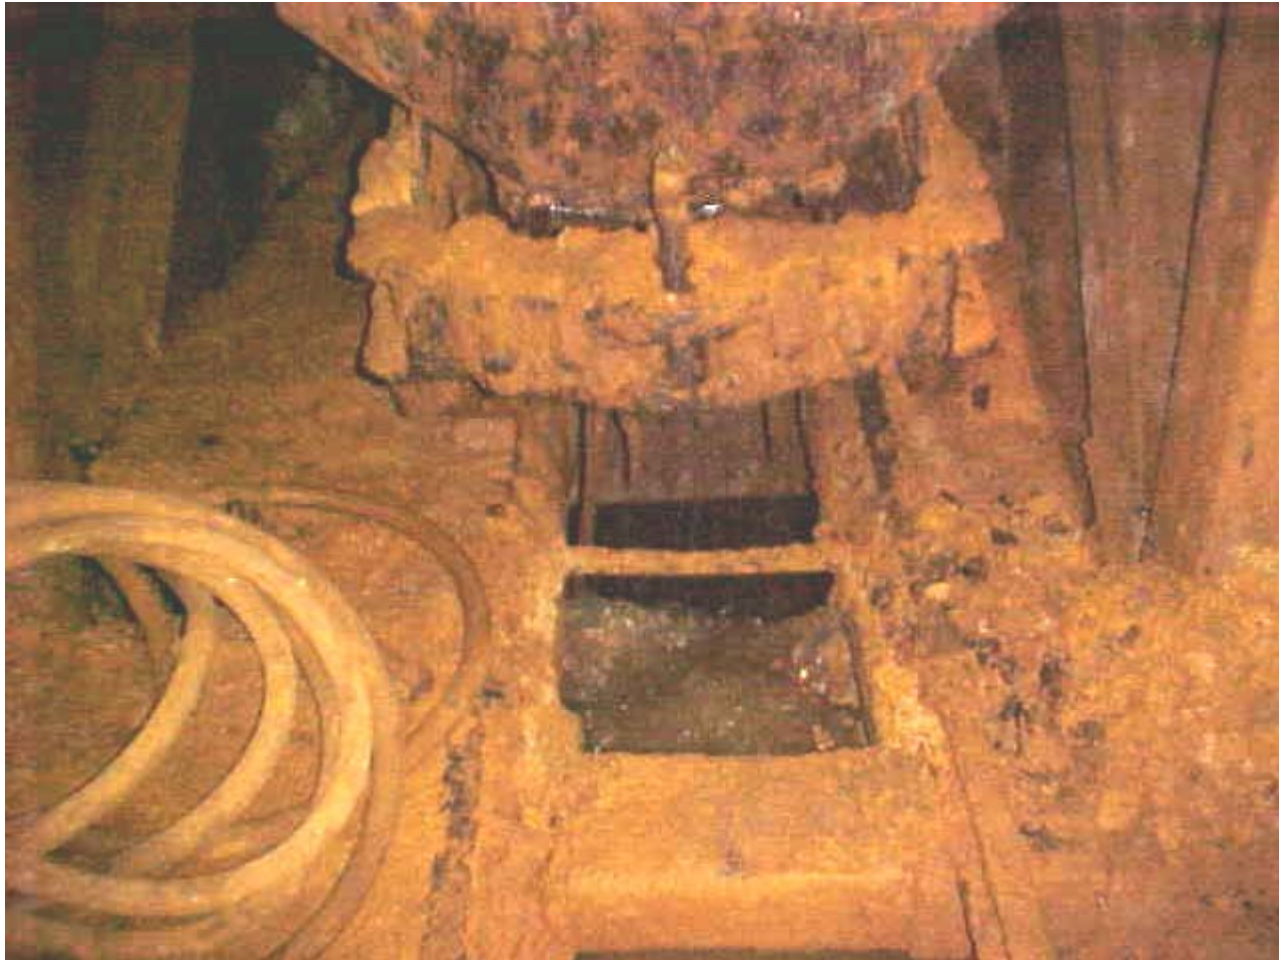
Dammed water draining down the Barney Vent Raise. The top of the raise is located below the old ore car.

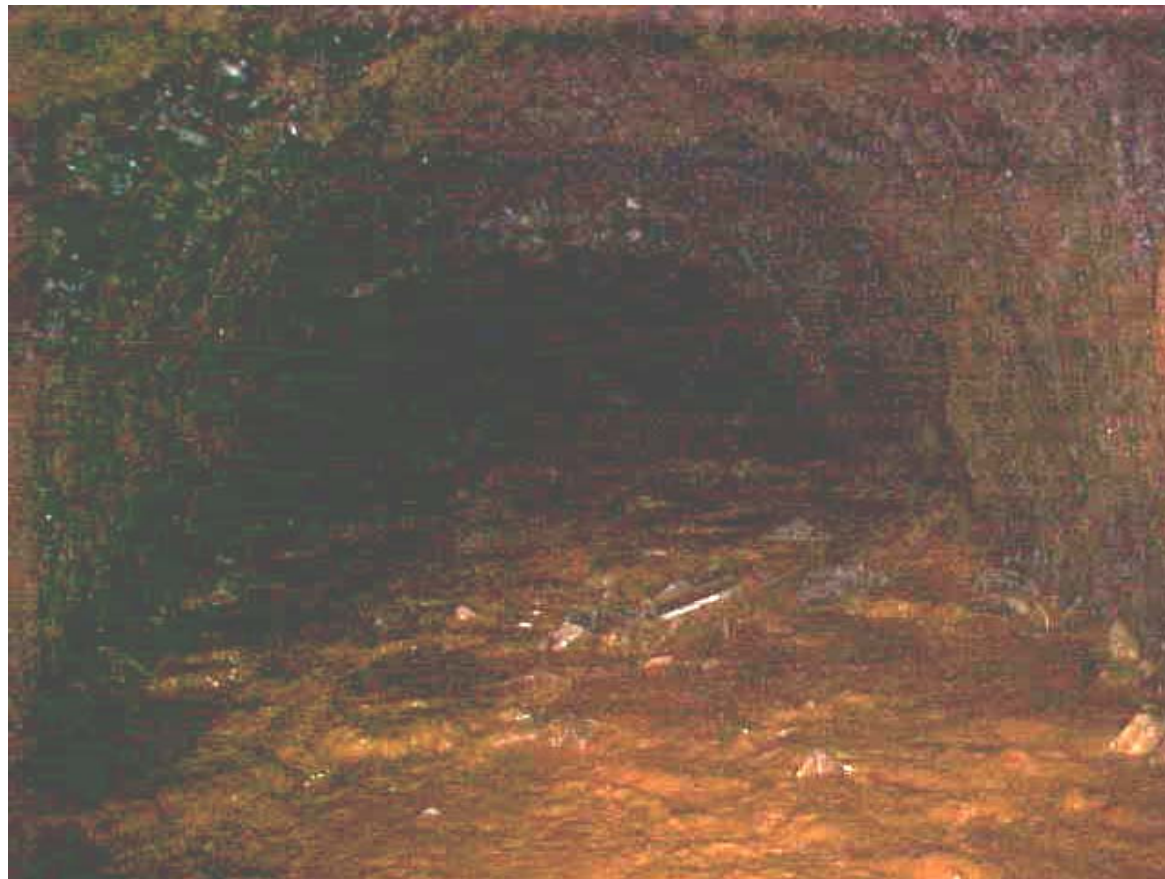
Looking upstream towards the bottom of the Barney Vent Raise on 10 Level. The bottom of the raise is about 200 feet up this drift. The debris and muck in the bottom of the drift accumulated when water drained into the raise to clean it out must have built up--then suddenly blew out carrying the debris with it. The diverted water is flowing across the top of the debris and muck. The depth of the debris increases towards the raise. At the back of this drift near the bottom of the raise the debris is up to within one to two feet of the ceiling. Removal of this debris would be very difficult. There appears to be adequate open space for water flow.
